## Test Report

No. SZXEC2202397501

Sample Name : LSB

### Halogen

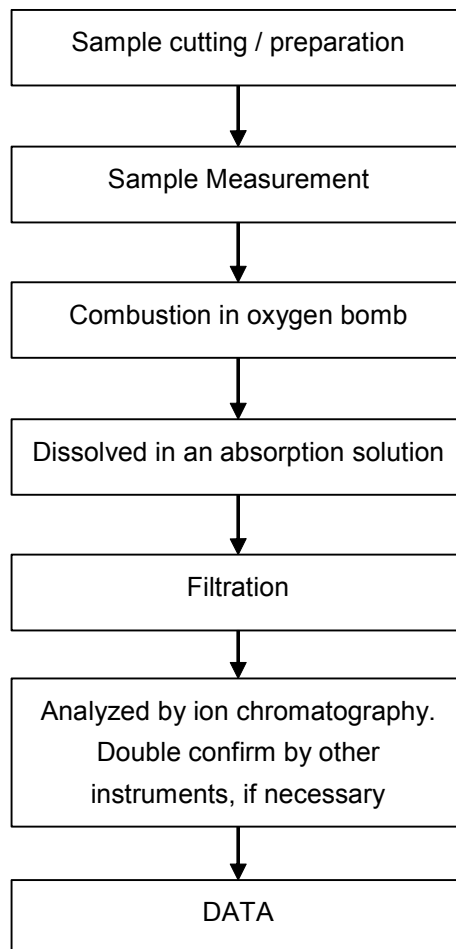
## Halogen Testing Flow Chart

Test Method : With reference to EN 14582:2016, analysis was performed by IC.

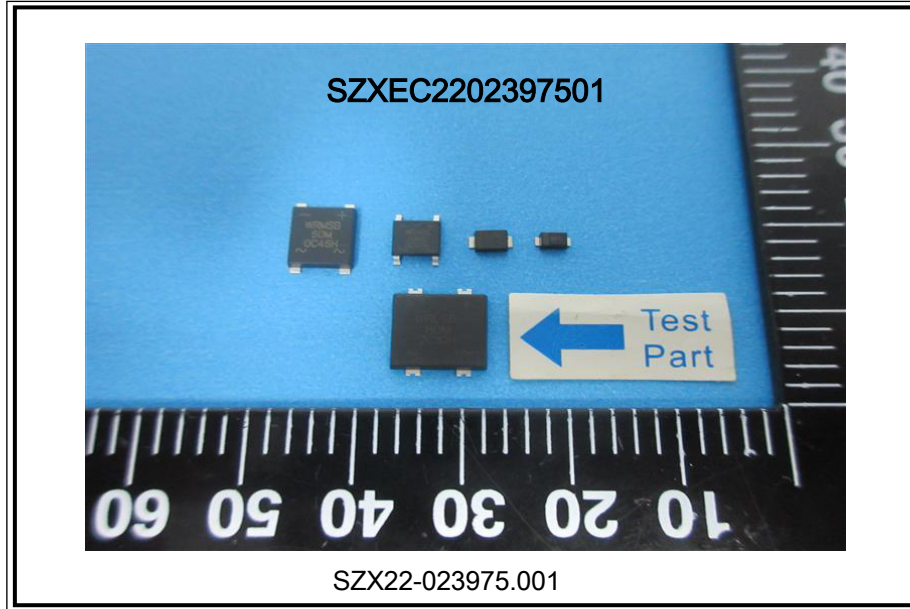
Sample photo:

Specimen No.	SGS Sample ID	Description
SN1	SZX22-023975.001	"LSB"((mixed)
